Manhole Inspection Summary

Manhole # S39CC_030MH

Insp Date: **4/8/09 4:05 PM**

Location Address: **HARFORD AVE**

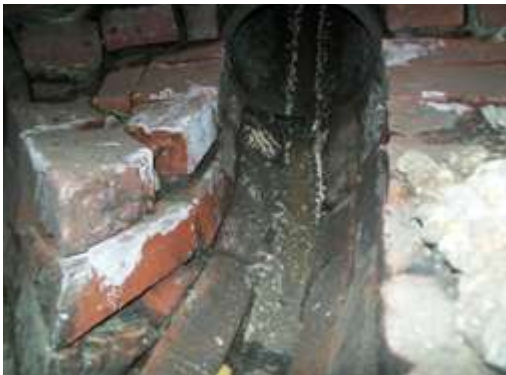
Defect 7

Condition: ☐ Sound ☒ **Cracked** ☐ Root Intrusion ☒ **Deteriorated** ☐ Leaks ☐ Debris

DETERIORATED BENCH BETWEEN I5 AND I7

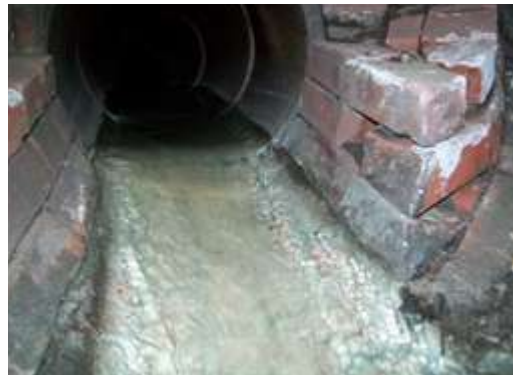
Defect 6

DETERIORATED BENCH AT RIGHT

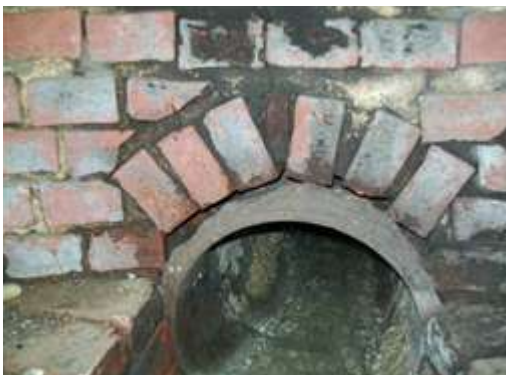
Defect 5

Infiltration: ☐ None ☐ Joint ☐ Cracks ☐ Mortar ☐ Roots ☒ **Wall**

EVIDENCE OF INFILTRATION IN BARREL WALL ABOVE O12

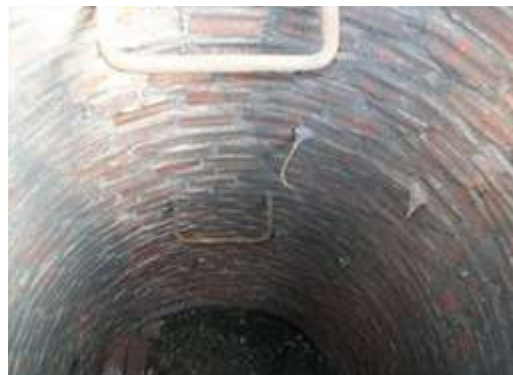
Defect 4

Count: **1** Missing: **6** ☒ **Corroded**

CORRODED AND MISSING STTEPS

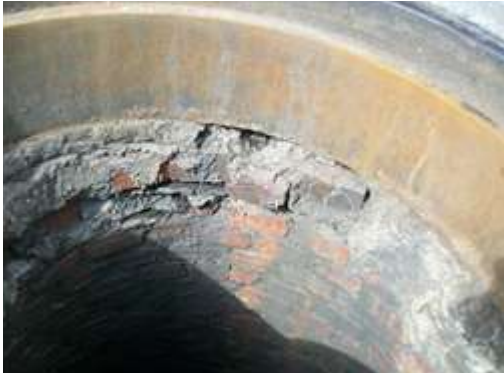
Defect 3

Offset: **2** (in.)

FRAME OFFSET

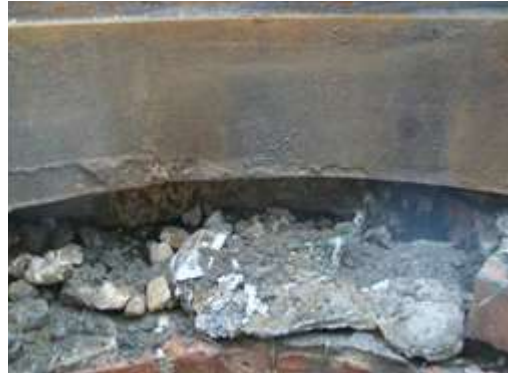
Defect 2

GAP BELOW FRAME

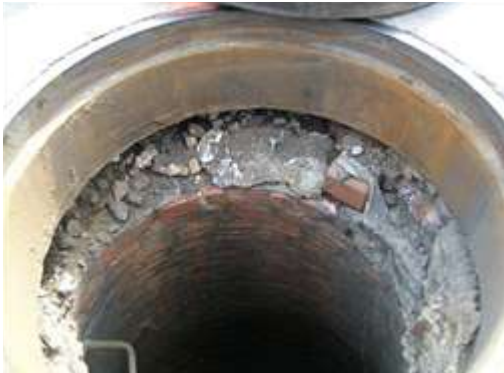
Defect 1

Condition: ☐ Sound ☒ **Cracked** ☐ Root Intrusion ☒ **Loose Brick** ☒ **Deteriorated**

DETERIORATED AND CRACKED
CHIMNEY WITH LOOSE BRICKS

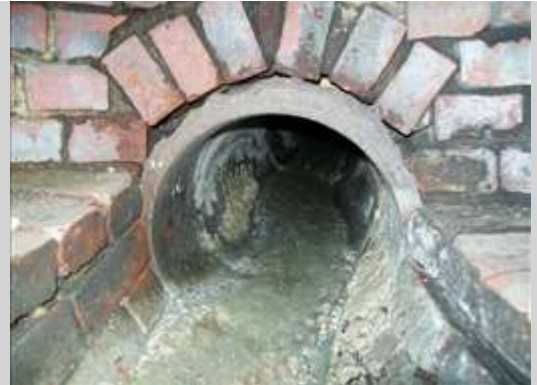
12 O'Clock Outflow

LIGHT DEPOSITS OF GREASE

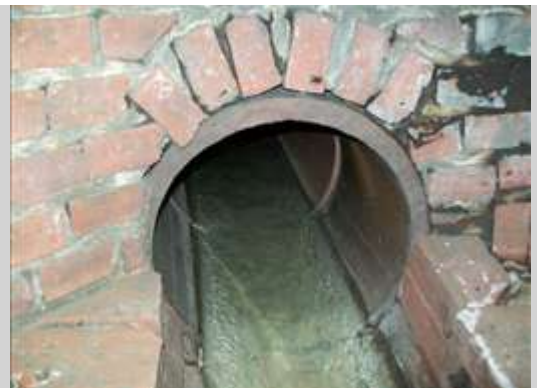
5 O'Clock Inflow

LIGHT DEPOSITS OF GREASE
